Manhole Inspection Summary

Manhole # S31MM1002MH

Insp Date: **3/26/07 1:44 PM**

Location Address: **4410 BEDFORD PL**

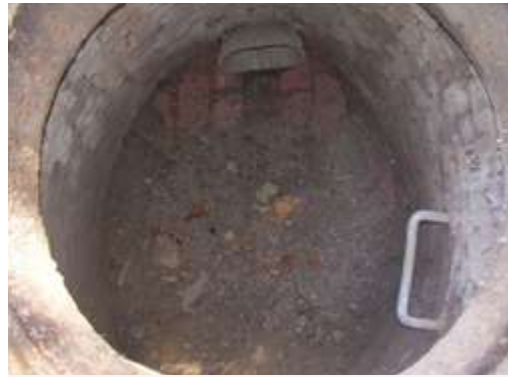
Top View

Channel debris.

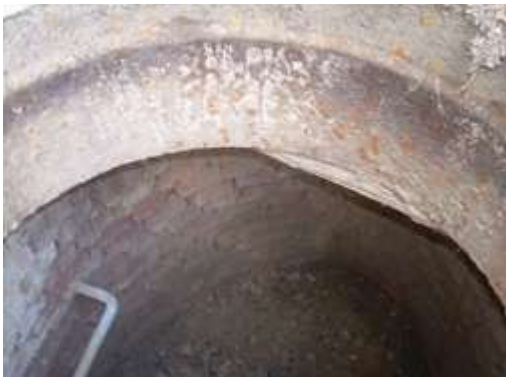
Defect

☒ **Leaks**

Condition: ☐ Sound ☐ Cracked ☐ Root Intrusion ☐ Loose Brick ☒ **Deteriorated**

Infiltration: ☐ None ☒ **Joint** ☐ Cracks ☐ Mortar ☐ Roots ☒ **Wall**

Infiltration: ☐ None ☐ Joint ☐ Cracks ☒ **Mortar** ☐ Roots ☒ **Wall**

Frame leaks. Corbel and Barrel deterioration and infiltration - other side.

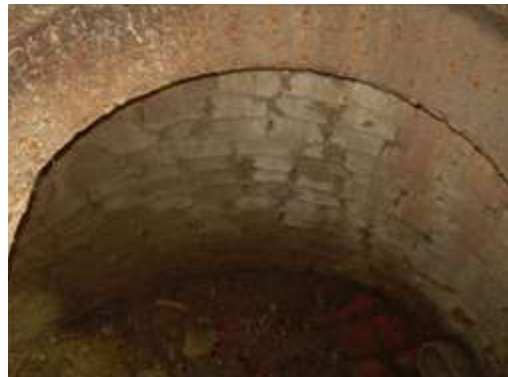
Defect

Frame leaks. Corbel and Barrel deterioration and infiltration.

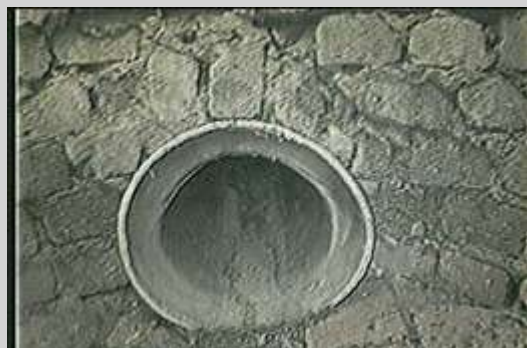
Pipe Out @ 12 O'Clock

Barrel deterioration and infiltration.
